McLaren steam traction engine No 815

This case study is part of a series developed by Powerhouse Museum Conservation department, May 2014.

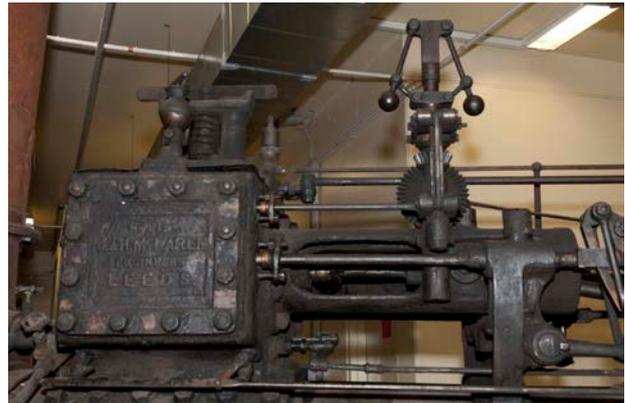
Detail of the McLaren label, cylinder block and governor (speed controller).

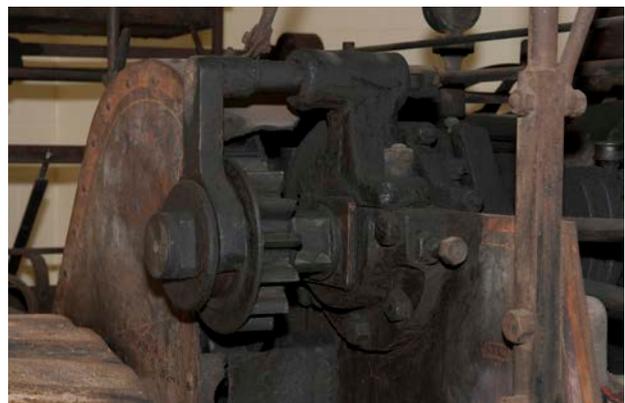
Original paint and line work is still visible on the gear cover and horn plates.

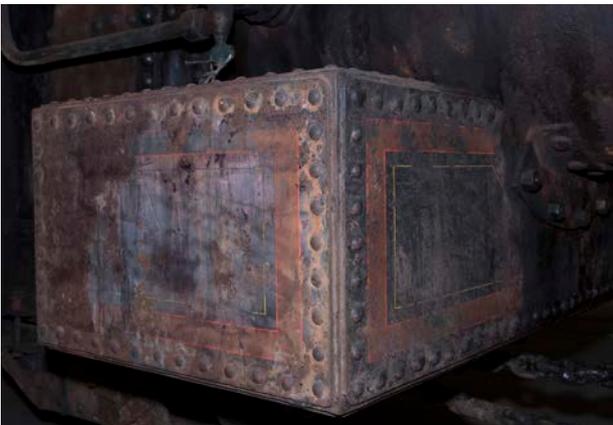
The belly water tank shows skilful, original, handpainted line work.

- There are blisters, pitting and perforation of steel in the belly water tank, due to acidic combustion products and moisture.
- The footstep to the man-stand was broken. It has been repaired in service by plating and riveting on the nearside.
- The chimney has corroded in places.
- There is severe corrosion in the ash pan.
- The fire bars contain ash and show moderate corrosion.

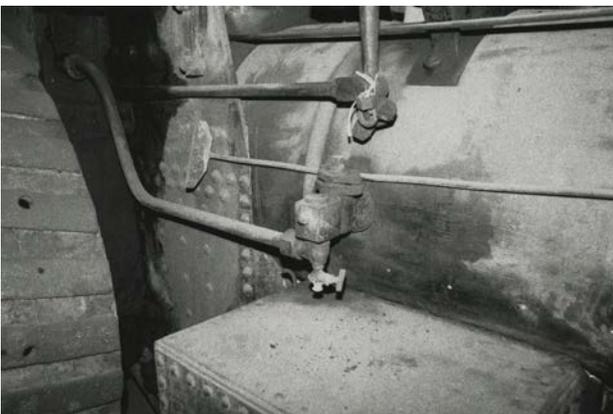
Spare nuts and washers located on the engine for reuse during its working days.

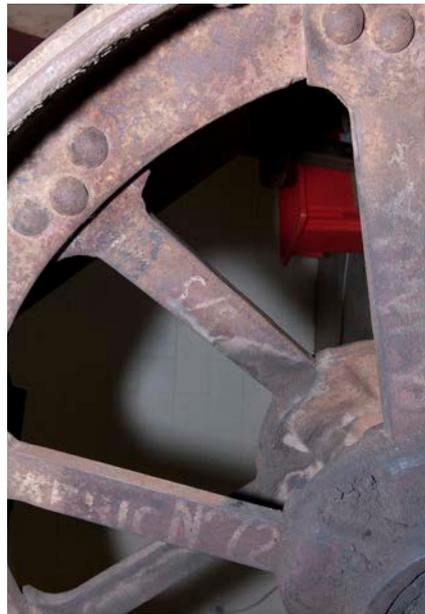
Important shipping details on the front wheel would have been lost if this engine had been restored.

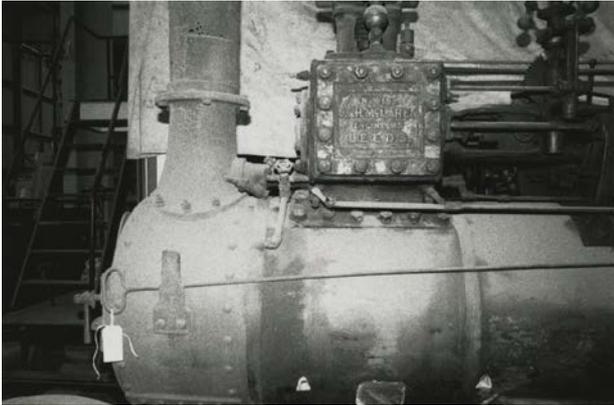
- Overall corrosion and paint loss but a large amount of original paint and line work survives.
- The boiler engine had corked asbestos cladding, used for insulation, sandwiched between the wooden lagging and the metal lagging on top.
- Heavy deposits of oxidised oil and grease, working grime and storage dirt.
- The stencilled shipping details are visible inside the front wheels.
- Severe corrosion in the floor of the smoke-box and on the door closing ring, caused by the acidic combustion products and moisture.
- Moderate corrosion to the front tube-plate and rivets but externally sound.
- The boiler interior, especially the tubes and the firebox crown, have corrosion blisters consistent with storing water, leading to splitting.

The engine before cladding was removed.

- Thorough black and white photography was undertaken before treatment began.
- The asbestos cladding was visible in some places. It was friable, could be disturbed if touched or tampered with, and was a health hazard, so the asbestos had to be removed. To do this, the metal lagging sheets of the boiler barrel had to be removed by unbolting and unscrewing all attachments. This was potentially dangerous as some of the existing surfaces could be damaged during this process. Some fittings and the chimney had to be removed to protect the paintwork.
- The asbestos was flooded in water first and then removed by the SRA Asbestos Unit.
- The engine was scrubbed down then dried off. It was reloaded and taken to the Museum's Castle Hill stores.

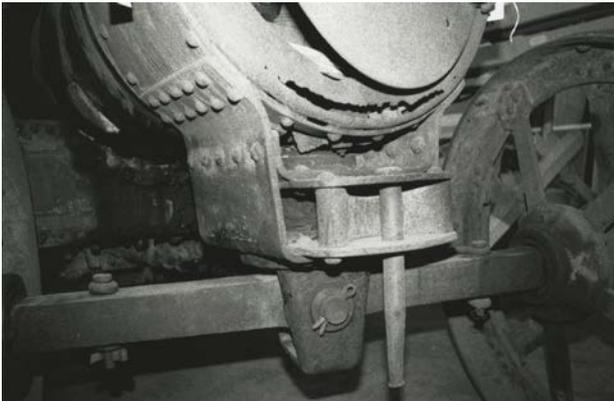
Corrosion to the smoke box.

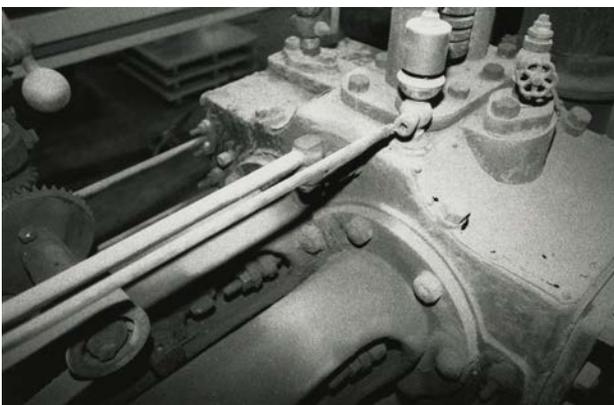
Cylinder block can hold moisture and cause corrosion.

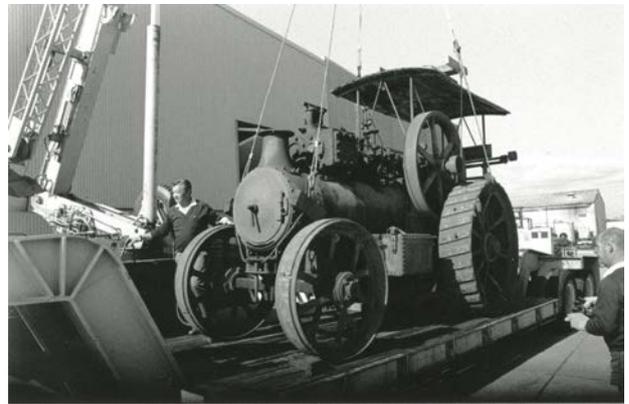
Moving the engine by crane from the Alexandria store.

The engine was moved from the Museum's Alexandria store to the Cooks River Yard, then loaded onto a well wagon and taken to the State Rail Authority (SRA) Asbestos workshops at Chippendale (Carriage Workshops, Eveleigh). In order to prevent any damage during the move, the following precautions were taken:

- rubber was placed over wheels and under chains
- soft nylon webbing was used over the roof for stability and also used to tie down loose objects
- loose bits were wrapped in bubble wrap.

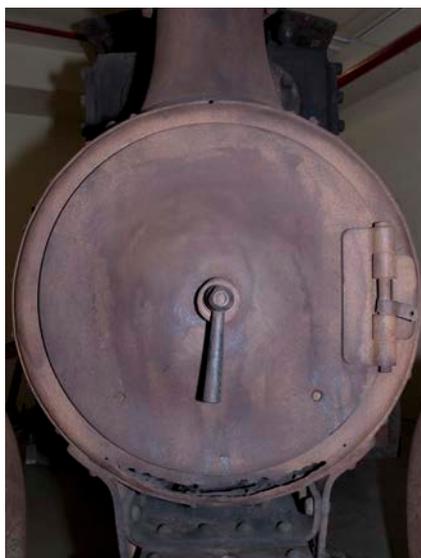
The smoke box after the ash was removed.

- The belly tank, the steering shaft, worm gear and some other fittings were put back in place.
- The exterior engine was sprayed with Rustico DW x30 which is a dewatering agent in oil that gives a protective coating.
- The boiler and the firebox were washed out with water to remove mud and rust.
- The boiler was dried with a dewatering agent (Corroless) to prevent further corrosion. This solution is no longer recommended.
- The fire-bars and the ash pan were removed and all the ash was taken out of the inner firebox, tubes and smoke box.
- All loose bits, pins and plugs have been stored in the tender.
- Thorough colour photography was undertaken.
